North West Transport Links East Environmental Impact Statement

Working Paper

EUROPEAN HERITAGE SURVEY

NORTH WEST TRANSPORT LINKS - EAST ENVIRONMENTAL IMPACT STATEMENT

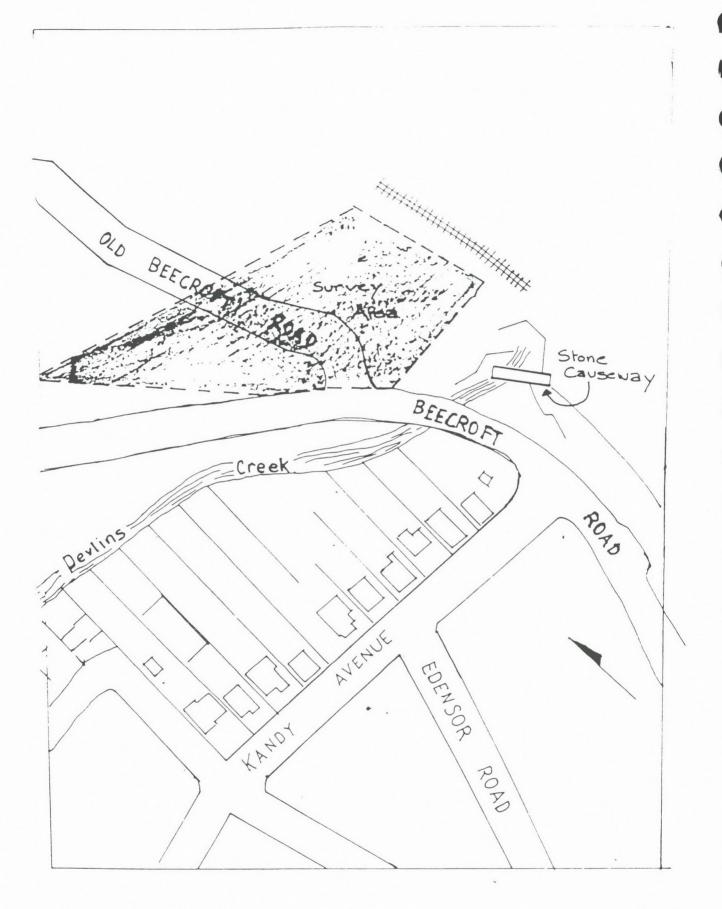
Figure 13 DEVLINS CREEK Survey & Causeway

The location and extent of the Devlins Creek road causeway, and associated area surveyed for this project, is shown in Figure 13. The causeway itself is located midway between the Beecroft Road and the main northern railway line, across Devlins Creek, at Epping. The area surveyed is located immediately north of this causeway, and occupies a trapezoid shape between Beecroft Road and the main northern railway line.

The causeway/road formation is approximately 20 metres long and 3 metres wide. It crosses Devlins Creek and disappears at either end beneath layers of later deposit, both alluvium and fill. In a number of sections the causeway has been cut, apparently to provide access for creek waters and to allow for insertion of pipes, (see Figures 14 to 15).

The pavement is formed by squared sandstone blocks with a worn upper edge and sparrow pecked edges (Figure 16). The outer edges of the pavement feature an edging formed by curved blocks. In a number of sections the central part of the paving is missing, indicating that the area beneath the pavement has been packed with sandstone rubble (Figure 17).

The road causeway itself is clearly a feature of considerable historical interest. At the very least it is recommended that appropriate protective measures should be taken during construction of the freeway. These would include fencing of the site, drawing its attention to all workers on site and nominating a person on site as being responsible for its protection.

It is strongly recommended that, prior to commencement of works on site, detailed recording of this feature should be undertaken and a full Conservation Plan should be prepared. This plan should address appropriate protective measures during construction, and appropriate long-term care and management of the site.

If excavation works occur in the vicinity of the causeway, these should be monitored so that appropriate recording/conservation can occur if significant sections of road or other features are discovered.

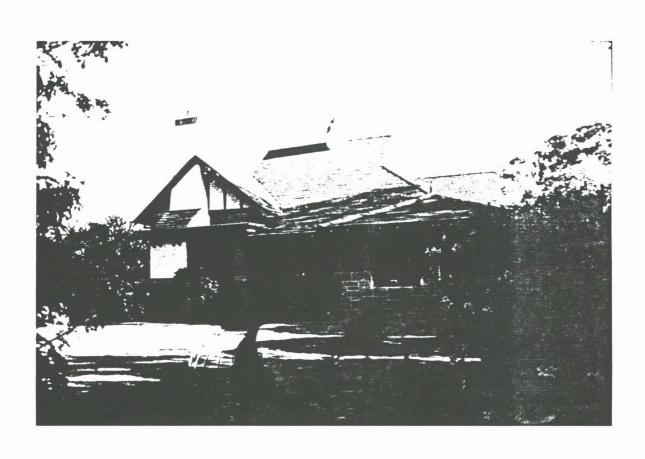
PHOTOGRAPH 4 157 Beecroft Rd, Beecroft Federation - Arts and Crafts style

This Beecroft area includes more individual Federation houses, evidencing Queen Anne and Arts and Craft styles, set on larger blocks with substantial gardens. (Photographs 3 and 4) Other properties in the area include Federation cottages of varying degrees of intactness. (Photograph 5)

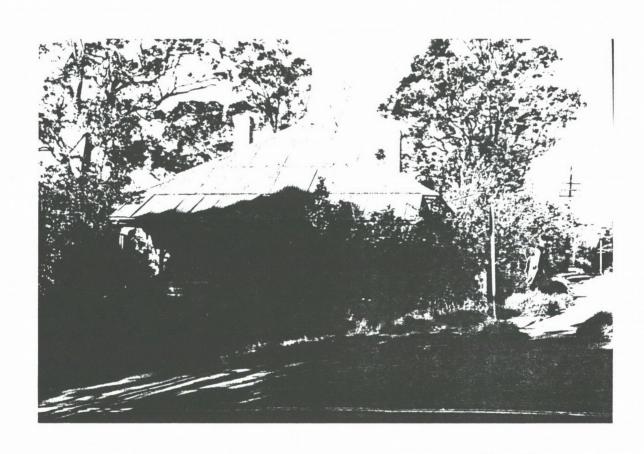
PHOTOGRAPH 6
'Carmel'
Cnr The Crescent and Beecroft Rd, Beecroft
Early cottage

Whilst the nature of the development is diverse within the study area, the architectural styles include isolated examples of early structures. An example occurs in the Crescent, Beecroft and in Fernhill Avenue, Epping (Photographs 6 & 7). These appear to be contemporary with structures along Carlingford Road (No 34 and 151).

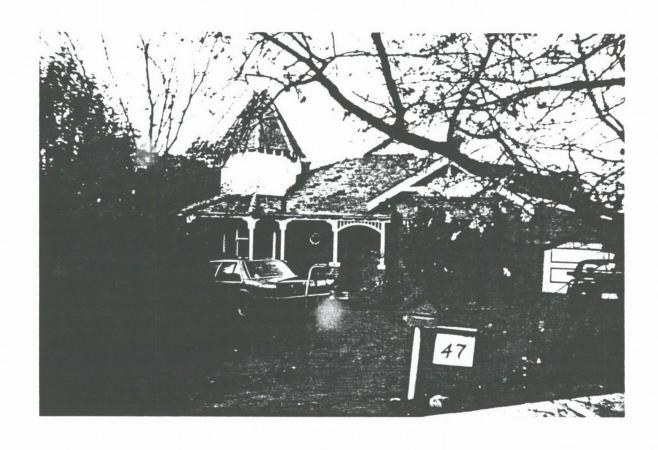
PHOTOGRAPH 9 47 Essex St, Epping Federation- 'Queen Anne' style

The Epping area is quite diverse in its development. The area to the east of the railway was developed first, however it is now quite mixed in its architectural character, comprising houses representative of Victorian, Federation and later styles. (Photograph 8, 9 and 10) The area to the west of the railway was developed later and has more uniform architectural character, being between the wars architecture and post world war two architecture. The area around the railway station, on both sides of the line, is predominantly modern walk-up flats.

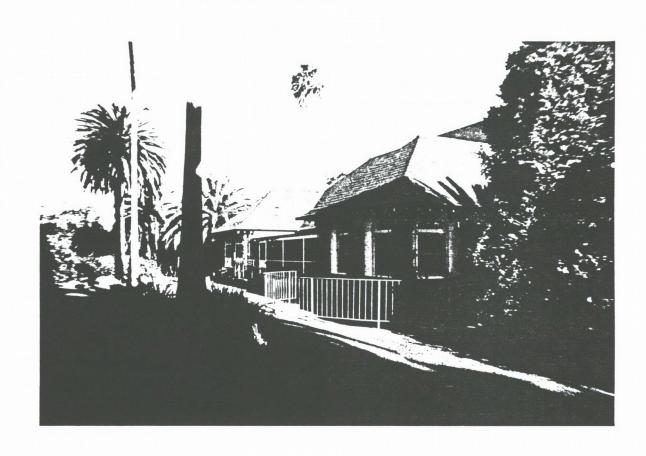
PHOTOGRAPH 14
'Chesalon'
The Anglican Home Mission Society
Beecroft Rd, Cheltenham

Areas in Cheltenham contain significant properties of architectural quality. These are included for comparison to the architecture of the affected route. The diversity of styles should be noted. The area includes houses from a number of periods including large early Federation to inter-war 'old English' and post war, streamlined-moderne style. (Photographs 14, 15 and 16)

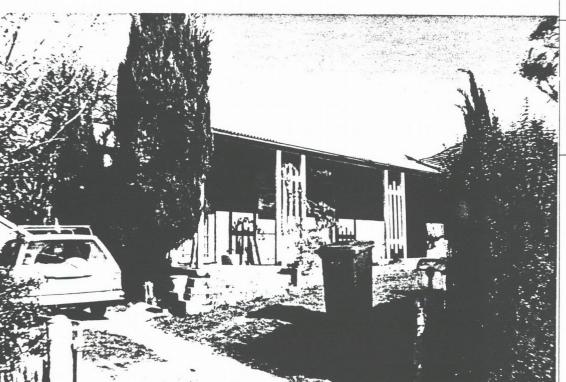
ENVIRONMENTAL IMPACT STATEMENT Inventory Sheet UBD REFERENCE NUMBER LOCATION 151 Carlingford Road, Carlingford Map: No: LAND TITLE DESCRIPTION DESCRIPTION An early possibly Victorian single storey, single fronted brick cottage with a hipped and gabled roof of corrugated sheet metal. The verandah once continued around at least three side of the house, however the side verandahs have been filled in. The paired timber verandah posts have timber trellis infill. PERIOD O 1788 - 1840 1841 - 1890 O 1891 - 1915 O 1916 - 1940 O 1941 - 1960 O 1961 - 1980 O 1981 - 1990 HISTORY Probably originally a two room cottage, dating from pre -1890. It appears to have been HISTORICAL CONTEXT either an early settler's cottage or orchardist's cottage. One of the earlier structures **O TRANSPORTATION** along Carlingford Road. O INDUSTRIAL RESIDENTIAL O COMMERCIAL REFERENCES Not Known O OTHER & SOURCES INTEGRITY O SUBSTANTIALLY INTACT PHOTOGRAPH / DIAGRAM Photograph roll 2 Negative No 11,12 ALTERED SYMPATHETICALLY

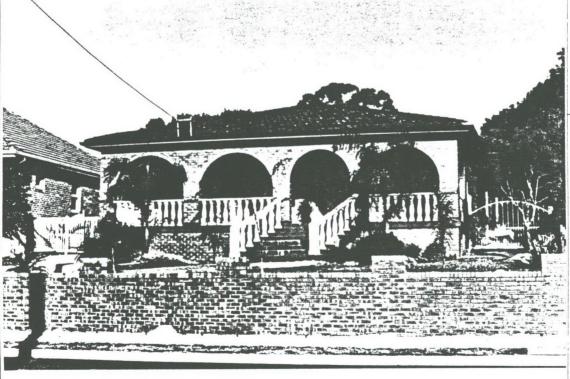
ASSESSMENT Intrusive building in possible conservation area.

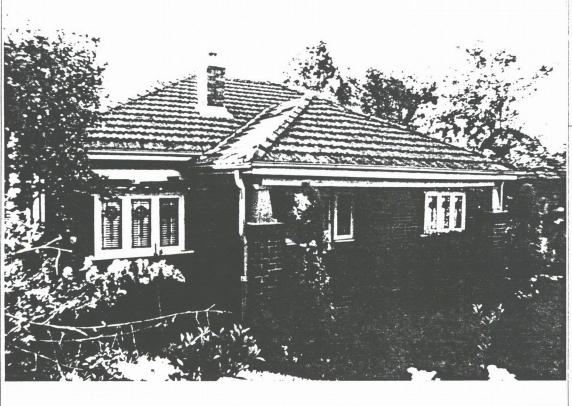
ASSESSMENT Of local interest. Part of possible conservation area.

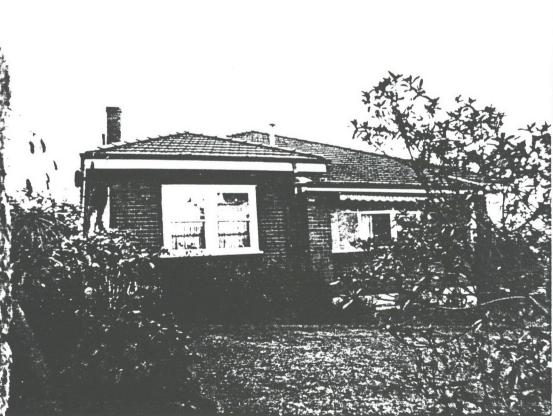
UBD REFERENCE NUMBER LOCATION 10 Carlingford Road, Epping Map: No: LAND TITLE DESCRIPTION DESCRIPTION A single fronted, single storey dark brick California Bungalow style house with hipped terracotta tile roof and exposed rafters. The house has a rendered base. A verandah is located on the eastern side, with brick balustrading and piers and a flat roof with exposed rafters. The projecting windows have been replaced with PERIOD aluminium framed windows, however the narrow flat awnings, with timber supports O 1788 - 1840 over remain. O 1841 - 1890 O 1891 - 1915 1916 - 1940 O 1941 - 1960 O 1961 - 1980 O 1981 - 1990 Part of the Hazelwood Estate HISTORY HISTORICAL CONTEXT O TRANSPORTATION O INDUSTRIAL RESIDENTIAL O COMMERCIAL REFERENCES Not Known O OTHER & SOURCES INTEGRITY O SUBSTANTIALLY INTACT PHOTOGRAPH / DIAGRAM Photograph roll 4 Negative No 34 ALTERED SYMPATHETICALLY ALTERED UNSYMPATHETICALLY O REVERSIBLE HERITAGE LISTINGS O NATIONAL ESTATE O HERITAGE ACT O NATIONAL TRUST O RAIA 20th CENTURY O NPWS O LOCAL HIST SOURCES O LOC/REG ENV PLAN ASSESSMENT Of local interest. Part of a possible conservation area. DATE OF SURVEY 18.7.91 OINT **⊚ EXT** BY PR

ASSESSMENT Part of a possible conservation area

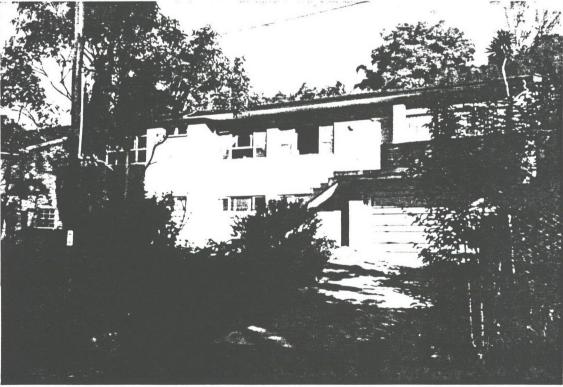
ENVIRONMENTAL IMPACT STATEMENT UBD REFERENCE NUMBER LOCATION 66 Pembroke Street, Epping No: LAND TITLE DESCRIPTION DESCRIPTION A single fronted, two storey light brick house, with a low gabled concrete tile roof and a garage at ground level. The windows are aluminium framed. PERIOD O 1788 - 1840 O 1841 - 1890 O 1891 - 1915 O 1916 - 1940 O 1941 - 1960 1961 - 1980 O 1981 - 1990 HISTORY Not Known HISTORICAL CONTEXT **O TRANSPORTATION** O INDUSTRIAL RESIDENTIAL O COMMERCIAL REFERENCES Not Known O OTHER & SOURCES INTEGRITY SUBSTANTIALLY INTACT PHOTOGRAPH / DIAGRAM Photograph roll 1 Negative No 2 **ALTERED** 0 SYMPATHETICALLY O ALTERED UNSYMPATHETICALLY O REVERSIBLE HERITAGE LISTINGS O NATIONAL ESTATE O HERITAGE ACT O NATIONAL TRUST O RAIA 20th CENTURY

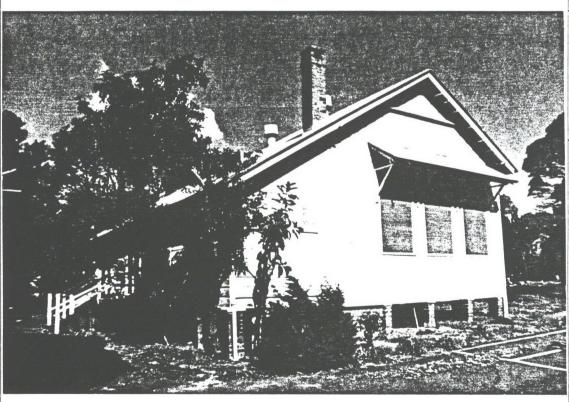
ASSESSMENT An early school, which shows evidence of the role of education in the outlying areas of Sydney. Of some historical interest. Not architecturally significant. DATE OF SURVEY 24.7.91

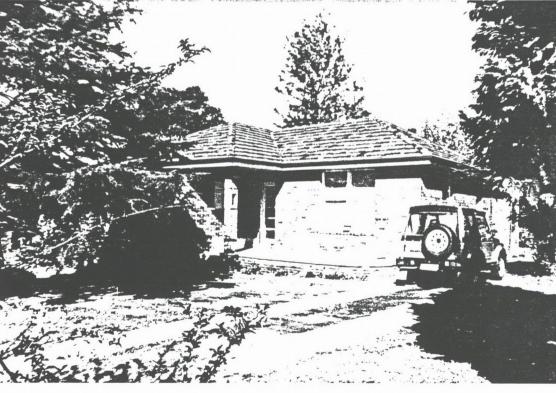
ENVIRONMENTAL IMPACT STATEMENT Inventory Sheet UBD REFERENCE NUMBER LOCATION 200 Epping Road, North Ryde Map: No: LAND TITLE DESCRIPTION DESCRIPTION An asymmetrical double fronted, single storey brick house with hipped terracotta tile roof and a small undercover porch which features a stone column and base. The windows are timber framed. PERIOD O 1788 - 1840 O 1841 - 1890 O 1891 - 1915 O 1916 - 1940 1941 - 1960 O 1961 - 1980 O 1981 - 1990 HISTORY Not Known HISTORICAL CONTEXT **O TRANSPORTATION** O INDUSTRIAL RESIDENTIAL O COMMERCIAL REFERENCES Not Known O OTHER & SOURCES INTEGRITY SUBSTANTIALLY INTACT PHOTOGRAPH / DIAGRAM Photograph roll 5 Negative No 15 ALTERED 0 SYMPATHETICALLY O ALTERED UNSYMPATHETICALLY O REVERSIBLE HERITAGE LISTINGS O NATIONAL ESTATE O HERITAGE ACT O NATIONAL TRUST O RAIA 20th CENTURY

ASSESSMENT Not Significant

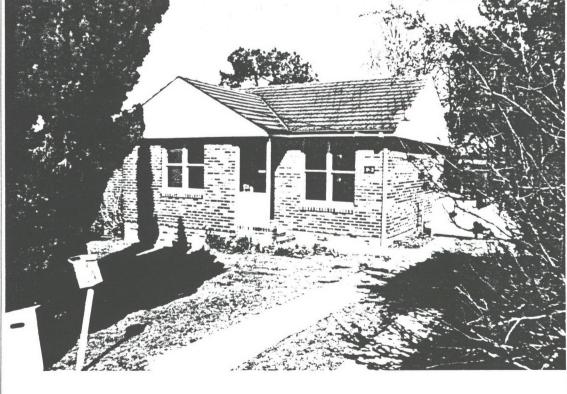
Inventory Sheet **ENVIRONMENTAL IMPACT STATEMENT** UBD REFERENCE NUMBER LOCATION 192 Epping Road, North Ryde Map: LAND TITLE DESCRIPTION DESCRIPTION A double fronted, single storey brick house with central projecting bay and gabled concrete tile roof with timber infill to gable ends. The windows are timber framed. PERIOD O 1788 - 1840 O 1841 - 1890 O 1891 - 1915 O 1916 - 1940 **1941 - 1960** O 1961 - 1980 O 1981 - 1990 HISTORY Not Known HISTORICAL CONTEXT O TRANSPORTATION O INDUSTRIAL RESIDENTIAL O COMMERCIAL REFERENCES Not Known O OTHER & SOURCES INTEGRITY SUBSTANTIALLY INTACT PHOTOGRAPH / DIAGRAM Photograph roll 5 Negative No 19 ALTERED 0 SYMPATHETICALLY O ALTERED UNSYMPATHETICALLY O REVERSIBLE HERITAGE LISTINGS O NATIONAL ESTATE O HERITAGE ACT O NATIONAL TRUST O RAIA 20th CENTURY O NPWS O LOCAL HIST SOURCES O LOC/REG ENV PLAN

ASSESSMENT Not Significant

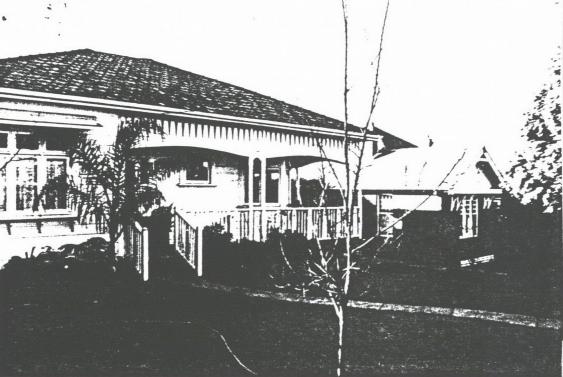
ASSESSMENT Local significance as good examples of Federation bungalows. Not proposed to be demolished, their visual integrity and setting will be compromised due to the

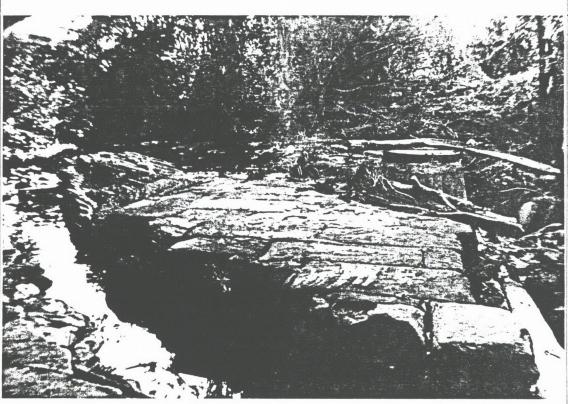
A sandstone paved road causeway, approximately 20 metres long and 3 metres wide crossing Devlins Creek. Sections have been cut out of the causeway for the insertion of pipes and to allow creek water to flow. The sandstone blocks are square in shape and have worn edges.

ASSESSMENT A Significant remnant of the Great North Road which opened areas to the north of Sydney to settlement and developemnt.. This is one ofthe few remnants left within the Metroplitan area.

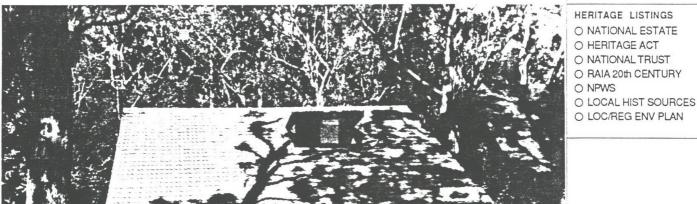
ASSESSMENT This property is too recent to allow proper assessment to be made. It is unlikely to be unique, however it is representative of the application of the design influences of the 'Sydney School' on speculative and 'kit' housing.
