Hoxton Park Road Upgrade

between Whitford Road and Cowpasture Road

Review of Environmental Factors

Appendices
November 2004

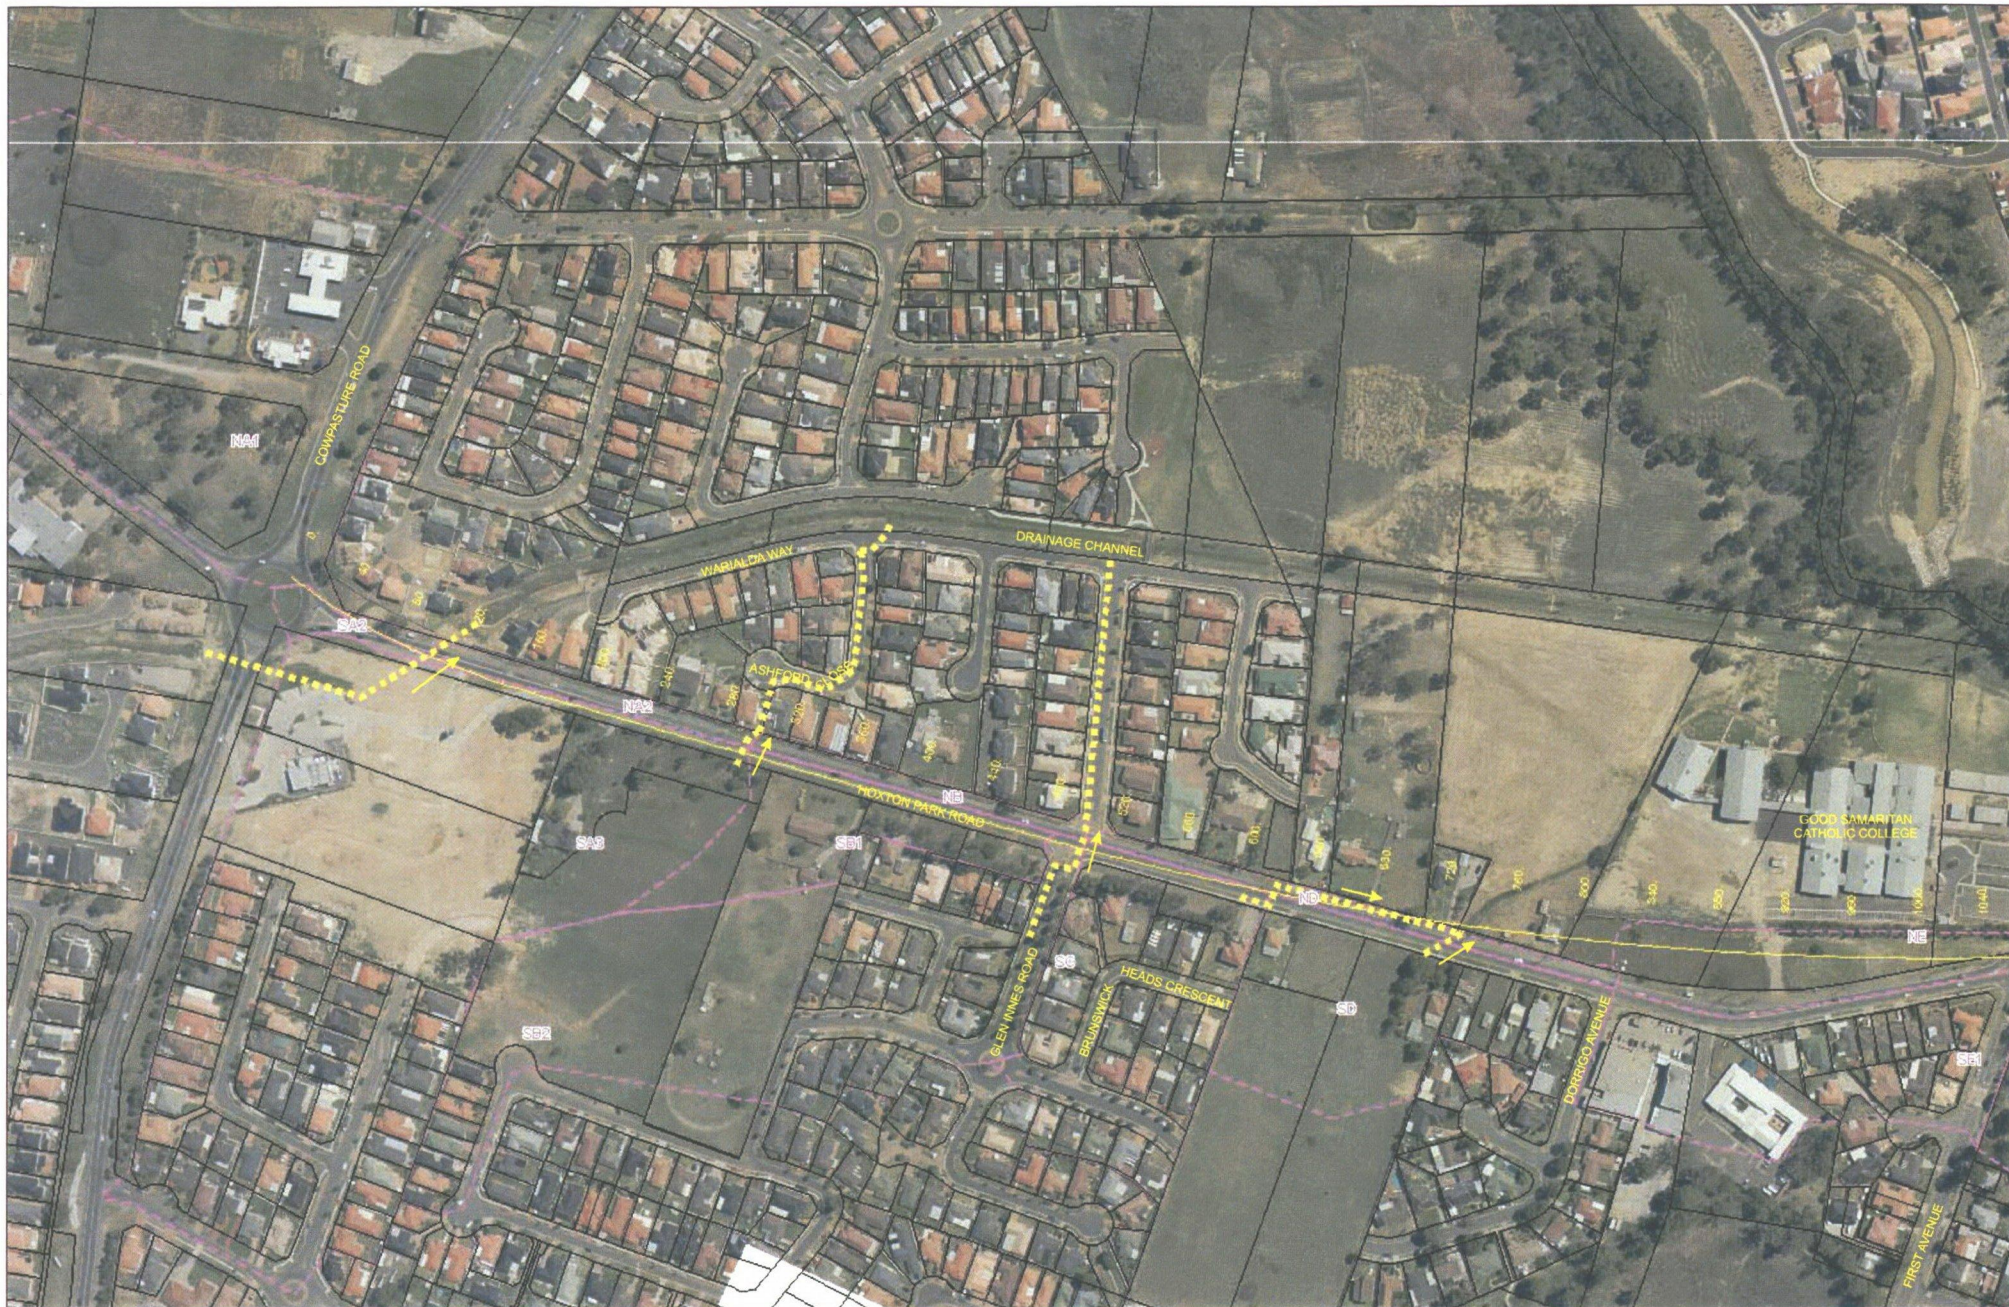
Figure 2.1

LOCAL CATCHMENT PLAN - WESTERN SECTION

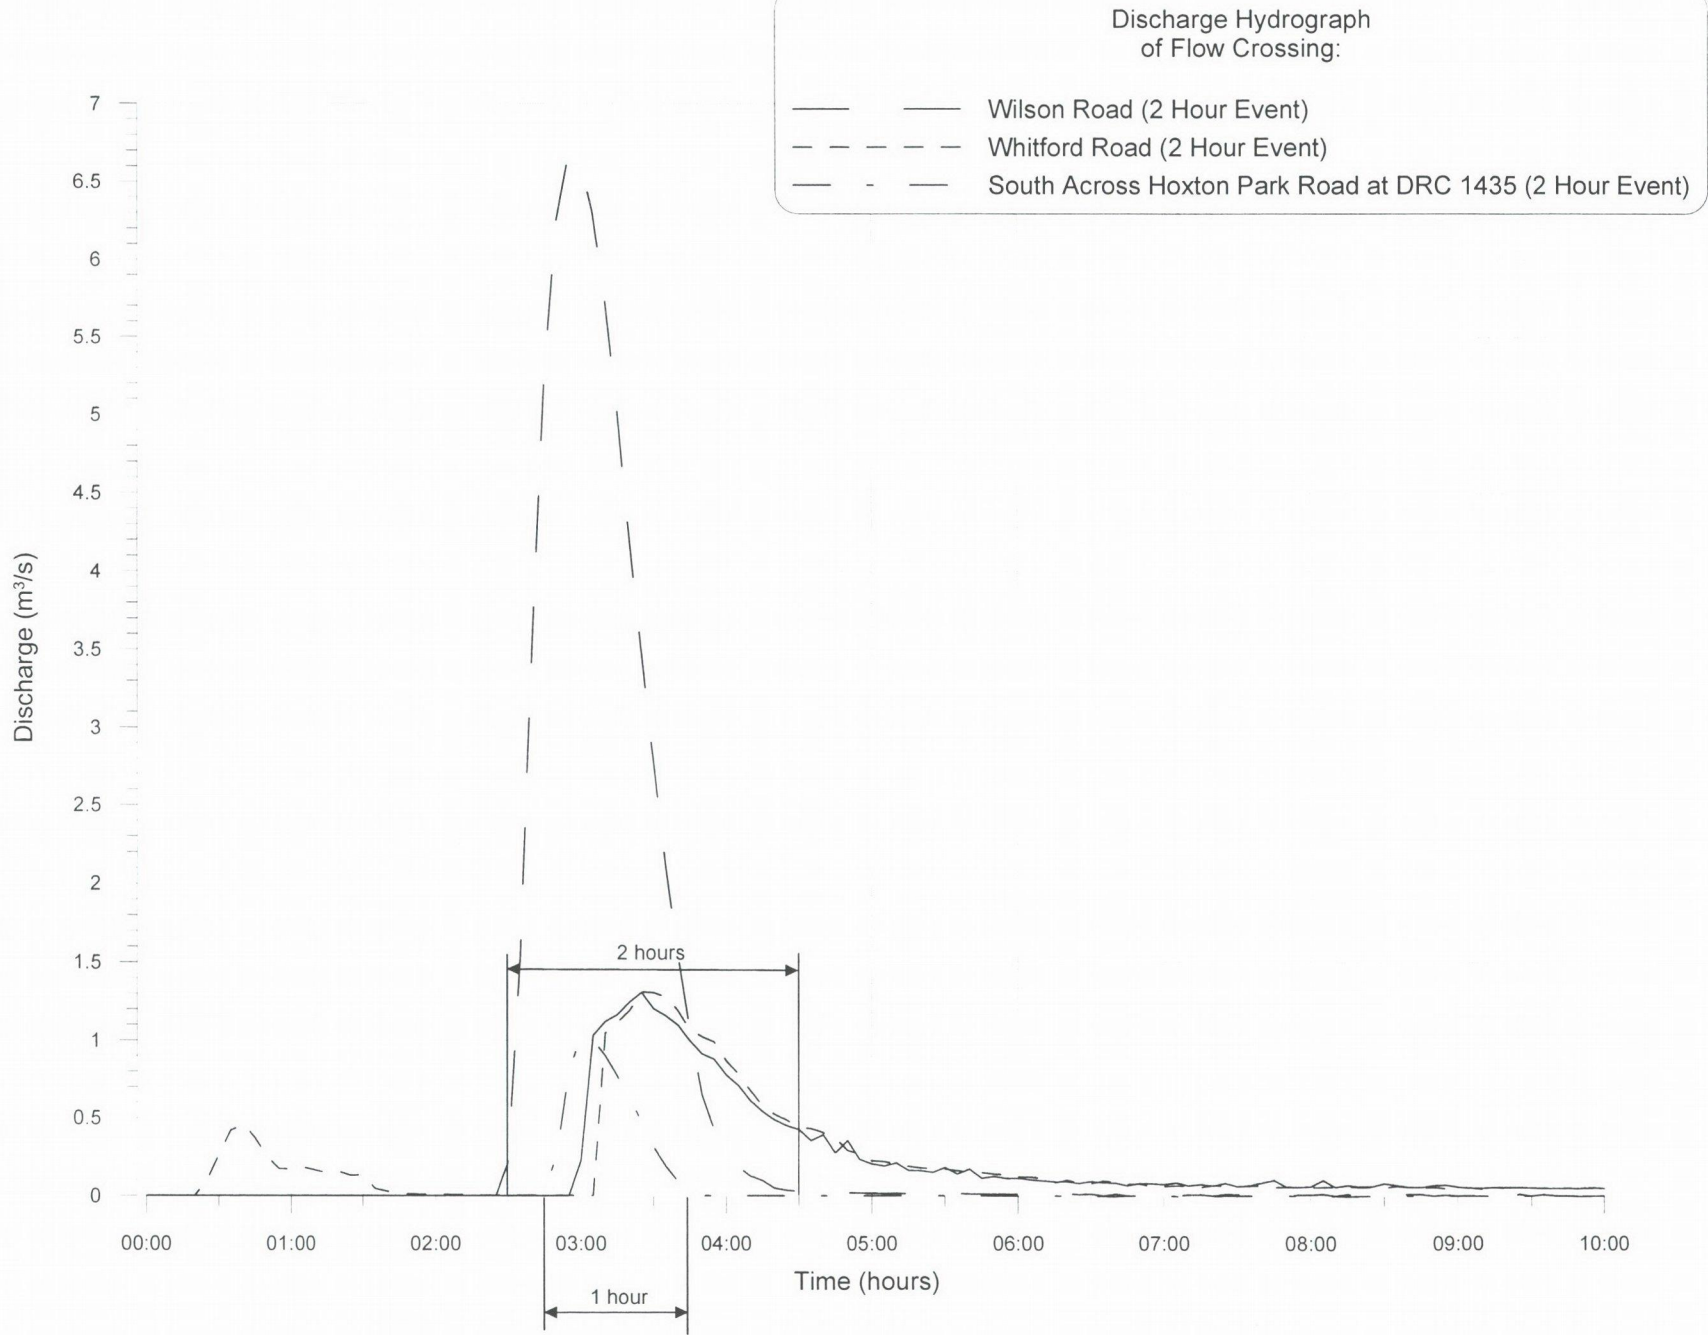
Figure 3.1

DISCHARGE HYDROGRAPHS
2 year ARI EVENT
PRESENT DAY CONDITIONS

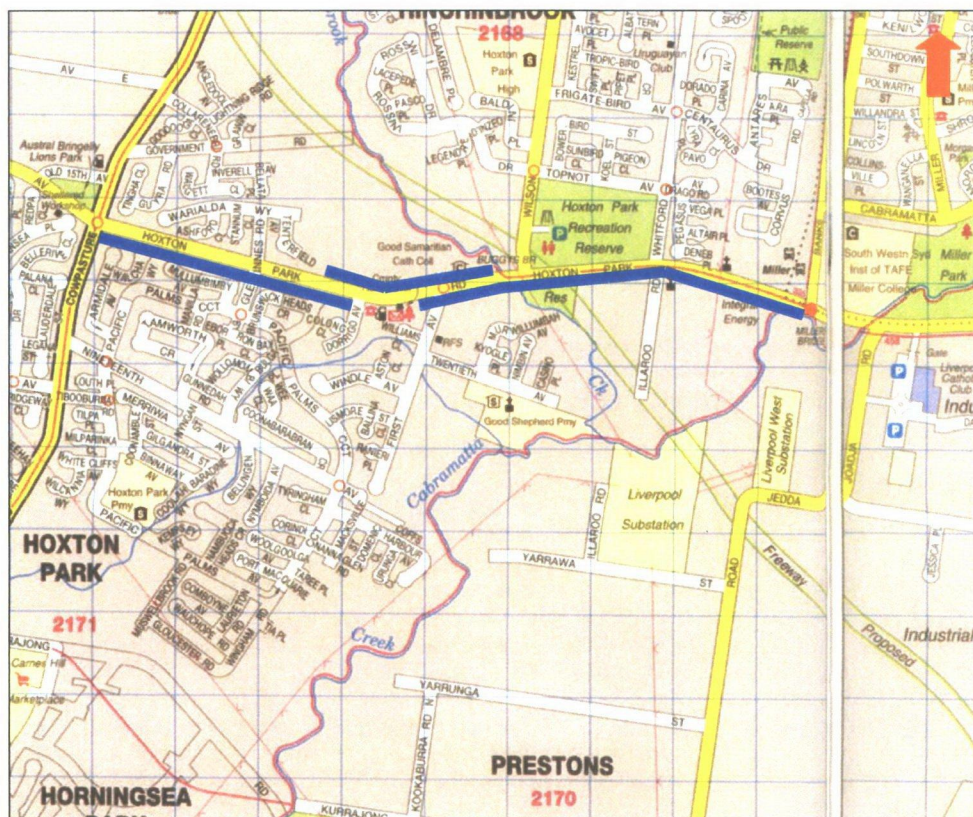
Figure 1.2 Schematic outline of the RTA concept plan for the widening of Hoxton Park Road, the blue line represents the side of the existing road to be widened.

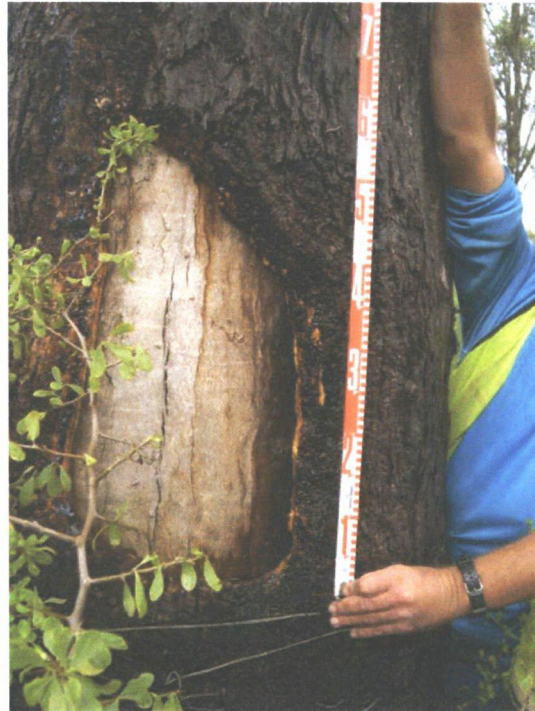
Plate 5.11 Site HPR3, note the asymmetrical scar and the wire around the trunk.

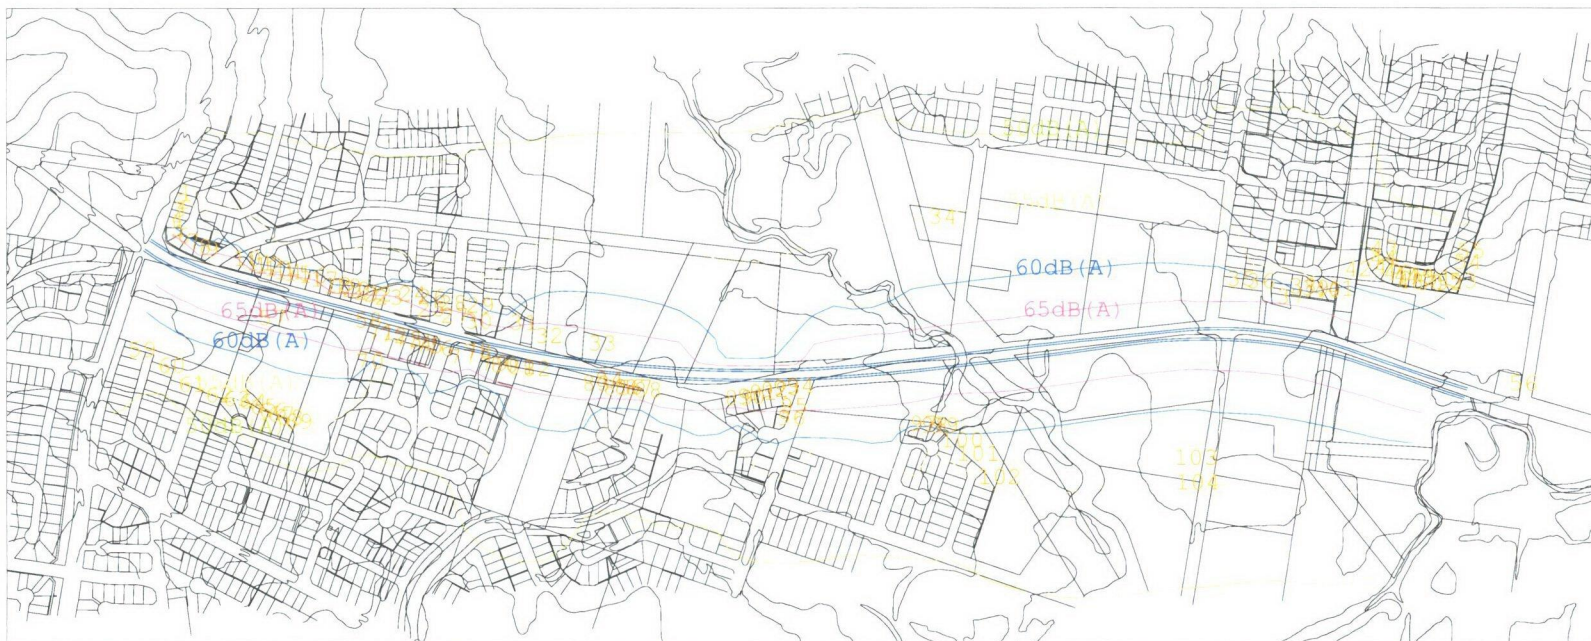
**PREDICTED $L_{Aeq,15hr}$ ROAD TRAFFIC NOISE CONTOURS
1.5m ABOVE GROUND LEVELS**

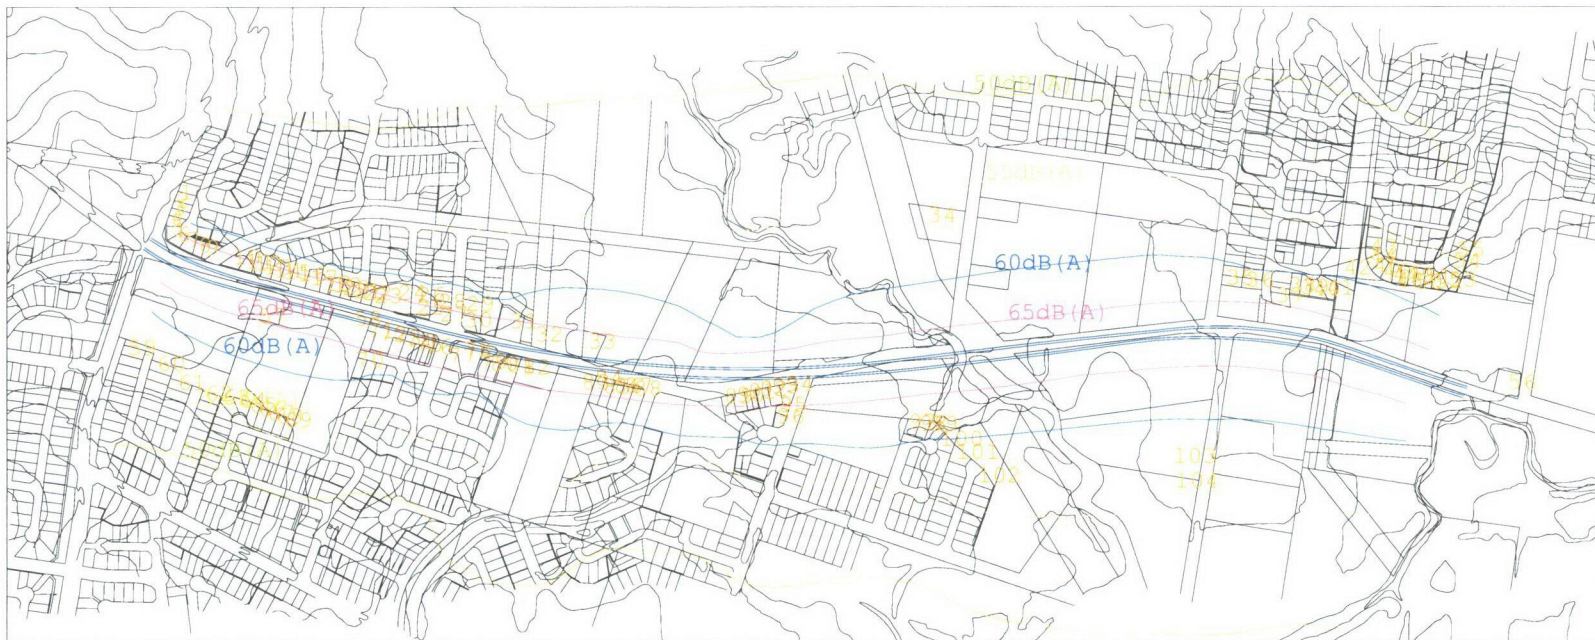
**PREDICTED $L_{Aeq,15hr}$ ROAD TRAFFIC NOISE CONTOURS
4.5m ABOVE GROUND LEVELS**

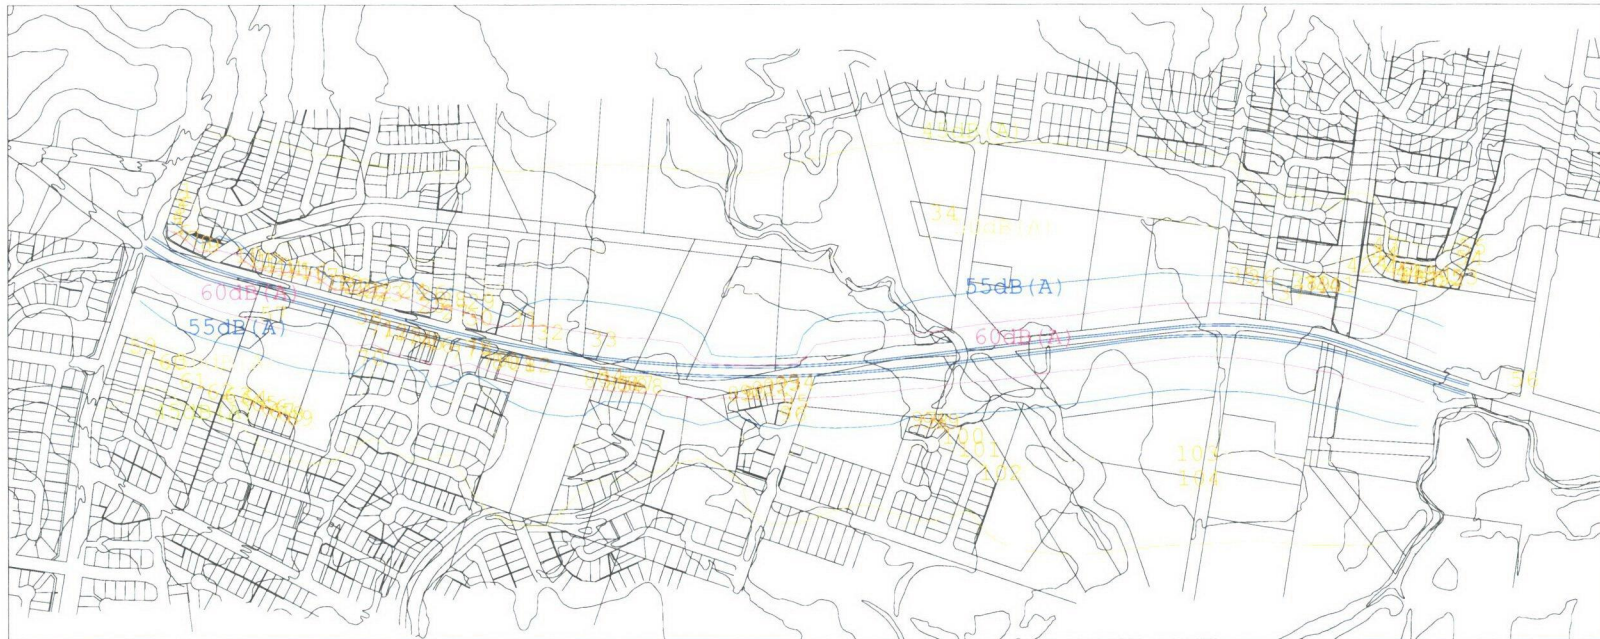
**PREDICTED $L_{Aeq,9hr}$ ROAD TRAFFIC NOISE CONTOURS
1.5m ABOVE GROUND LEVELS**

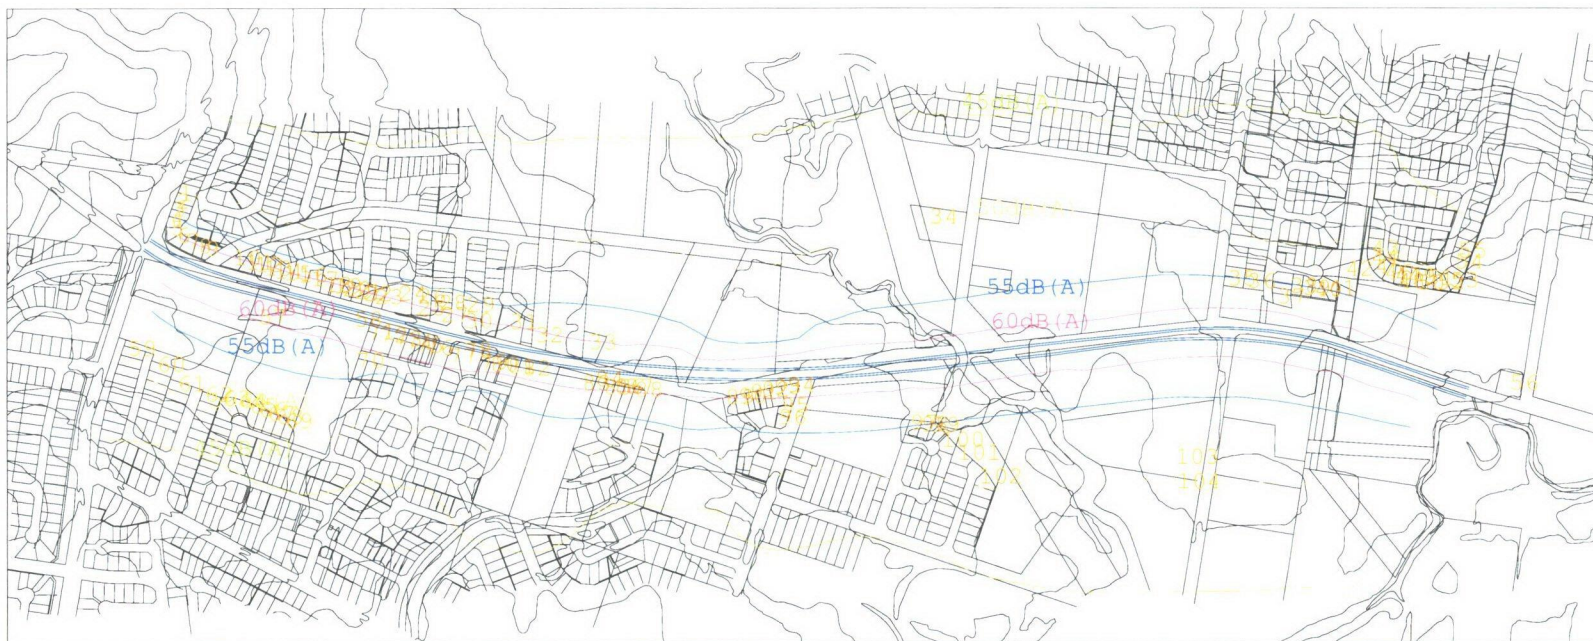
**PREDICTED $L_{Aeq,9hr}$ ROAD TRAFFIC NOISE CONTOURS
4.5m ABOVE GROUND LEVELS**
