REVIEW OF ENVIRONMENTAL FACTORS

REPLACEMENT OF THORNES BRIDGE OVER THE MULWAREE RIVER AT GOULBURN

Prepared by National Environmental Consulting Services for The Roads and Traffic Authority

May 2000

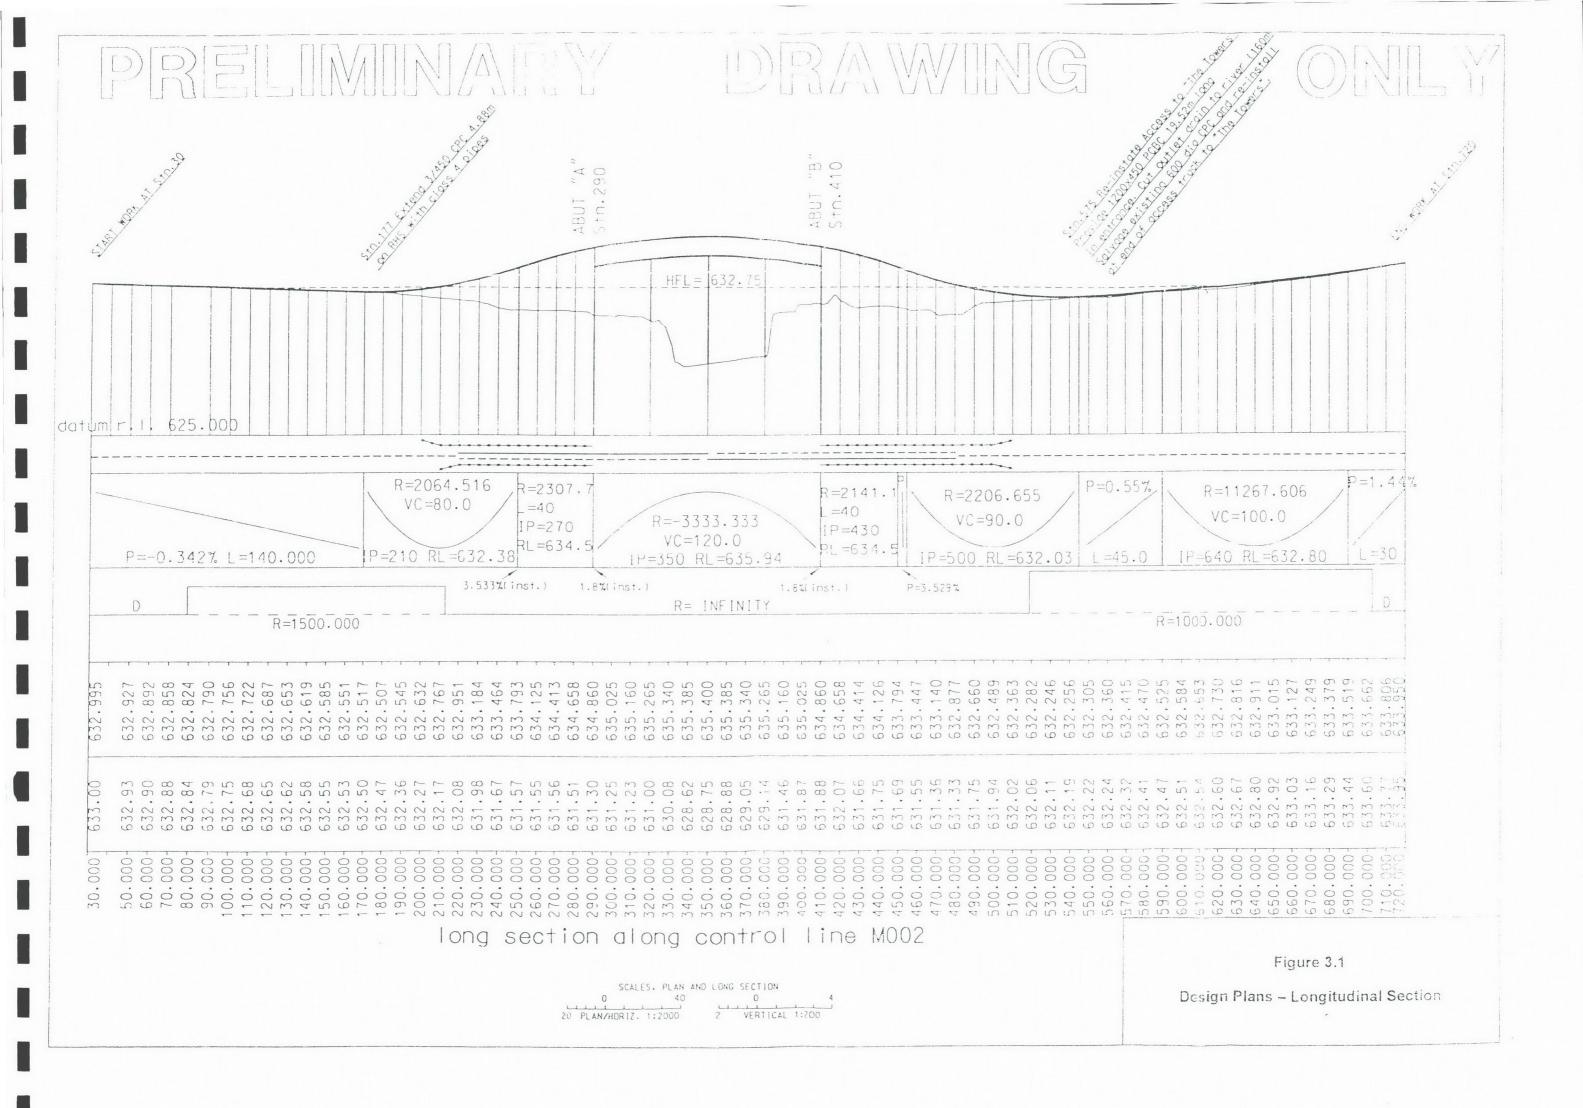
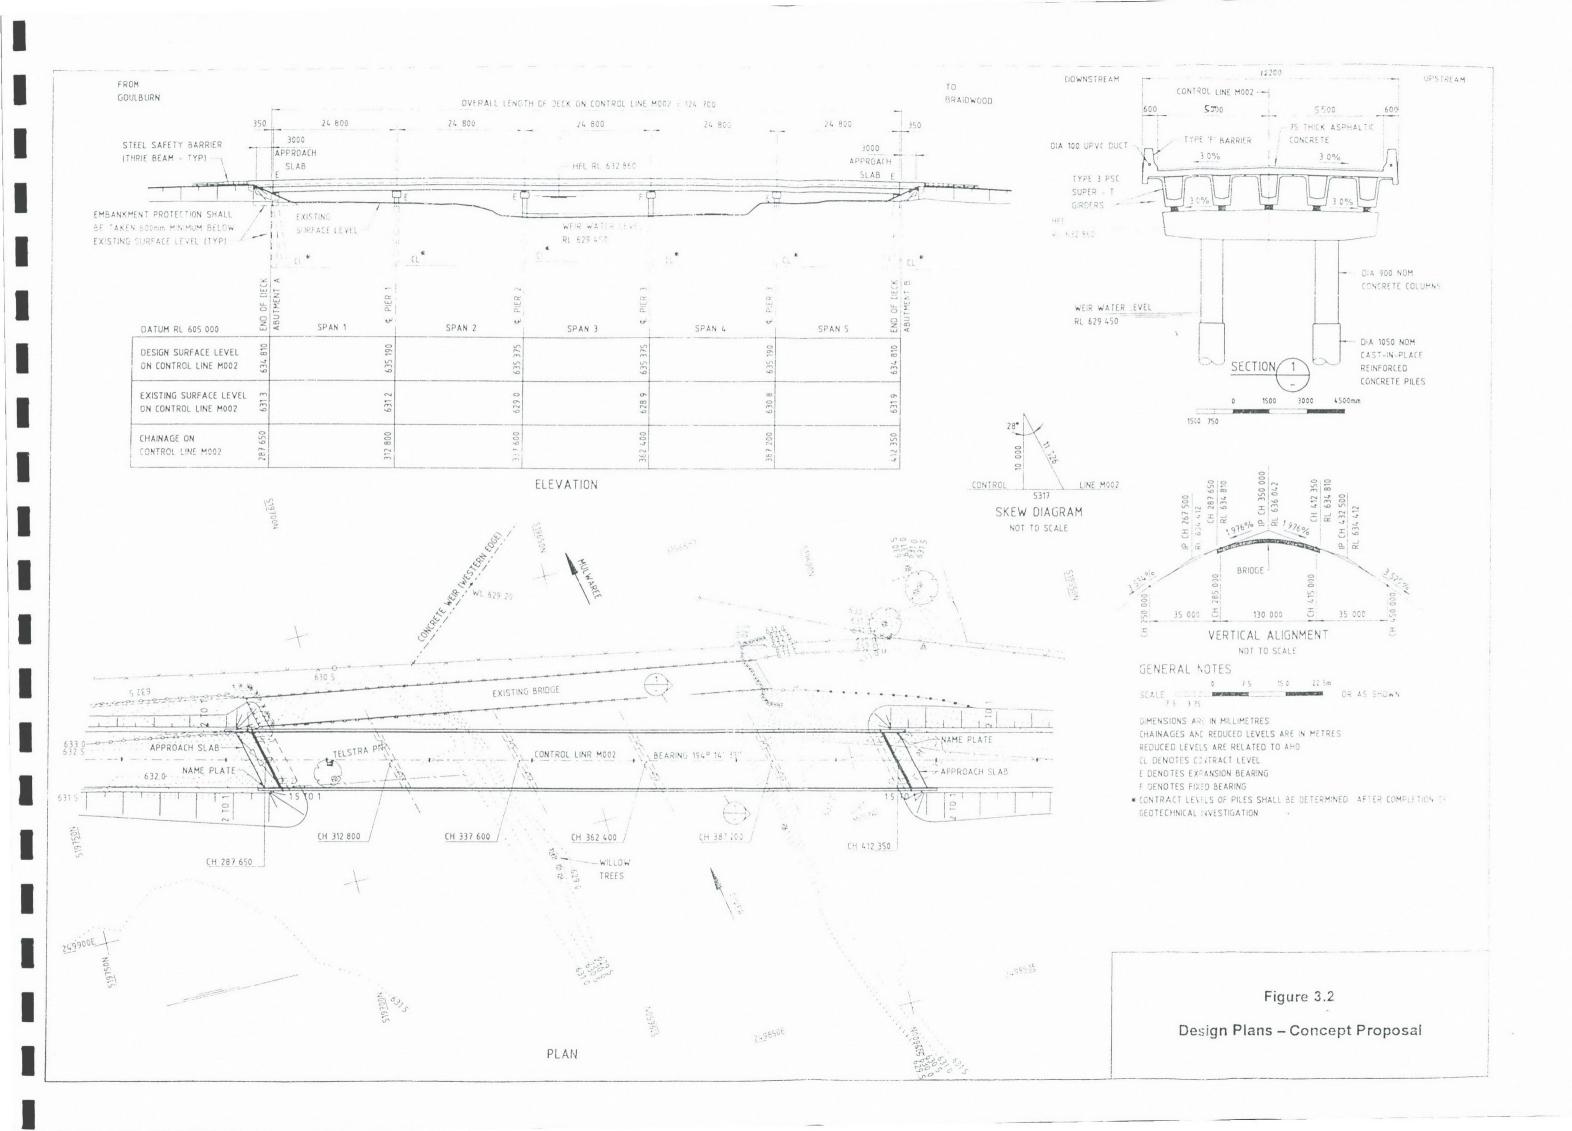
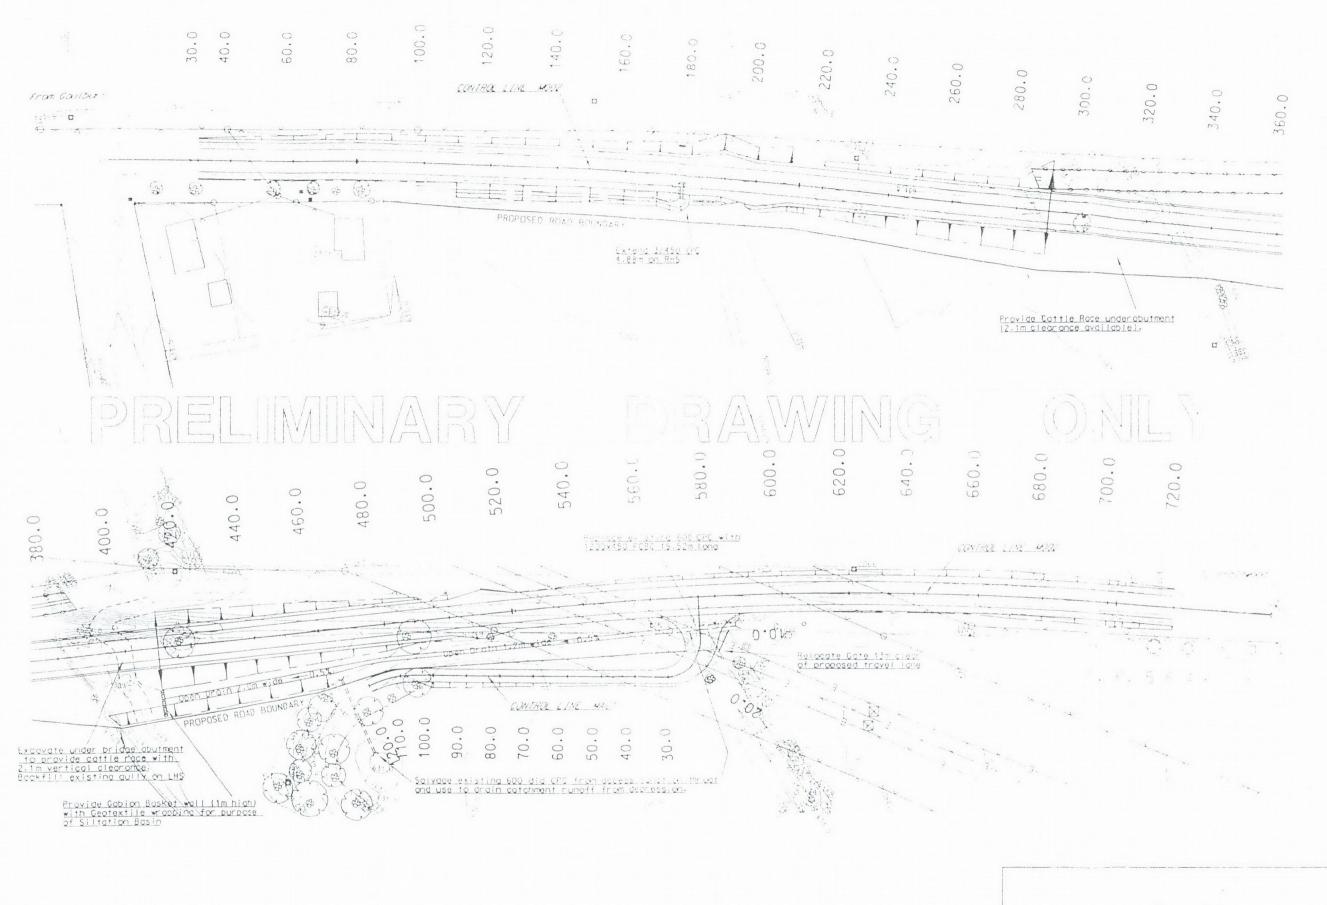
Figure 3.3

Figures 3.1 to 3.3 show the design plans for the proposed bridge.

Design Plans – Concept Detail Plan

The existing 9 span, 100 m long, timber truss and beam bridge would be replaced by a 5 span, 125 m long concrete bridge with a width between kerbs of 11 m. The proposed bridge width provides for 3.5 m lanes, 2 m shoulders and 1 m verge (embankment) and would allow for the bridge to be used safely by cyclists. The proposed bridge would consist of a reinforced concrete deck and kerbs on precast prestressed concrete Super-T girders supported by two reinforced concrete frame piers and three column frame abutments.

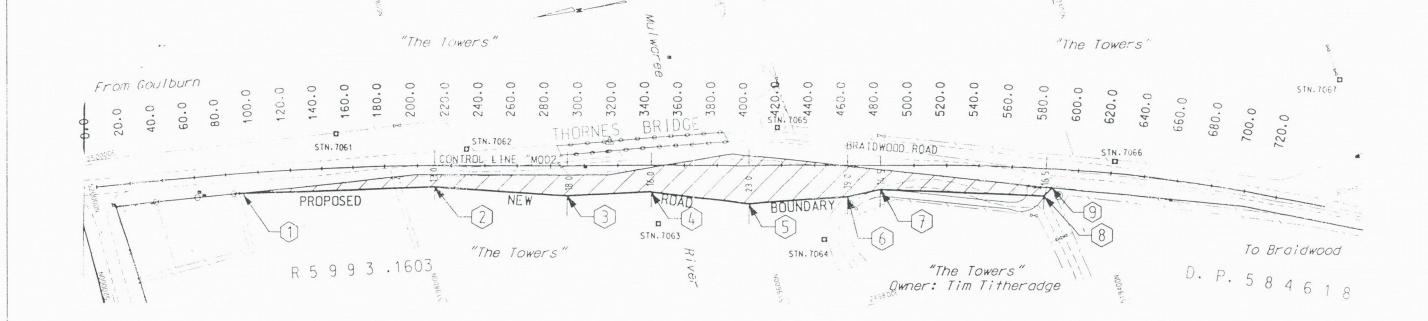
SURVEY CONTROL CO-ORDINATES

STATION	EASTING	NORTHING	HEIGHT
7059	249860.529	520002.434	634.948
7060	250000.000	520000.000	633.259
7061	249980.718	519841.919	632.315
7062	249951.873	519766.143	632.057
7063	249879.540	519665.520	631.345
7064	249845.347	519569.606	632.405
7065	249917.850	519580.699	632.983
7066	249847.470	519387.428	632.676
7067	249862.480	519244.395	634.181
7068	249797.085	519215.380	635.116
7069	249724.672	519117.635	636.640
STN1	249573.399	518780.338	640.124

The area covered by the proposed bridge and approaches is mainly situated within the existing road reserve. About 0.5 ha would need to be acquired from The Towers property, to the north and south of the Mulwaree River (refer Figure 6.1).

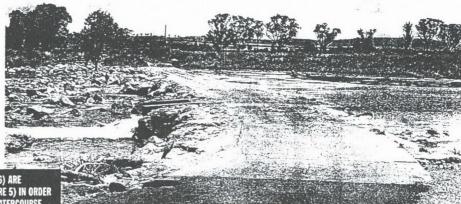
FIGURES 5 & 6: MULTI-CELL BOX CULVERTS (FIGURE 6) ARE PREFERRED OVER SINGLE CELL BOX CULVERTS (FIGURE 5) IN ORDER TO MAINTAIN THE CROSS-SECTIONAL AREA OF THE WATERCOURSE. HIGH FLOWS THROUGH THE CELL IN FIGURE 5 ARE A BARRIER TO FISH PASSAGE.

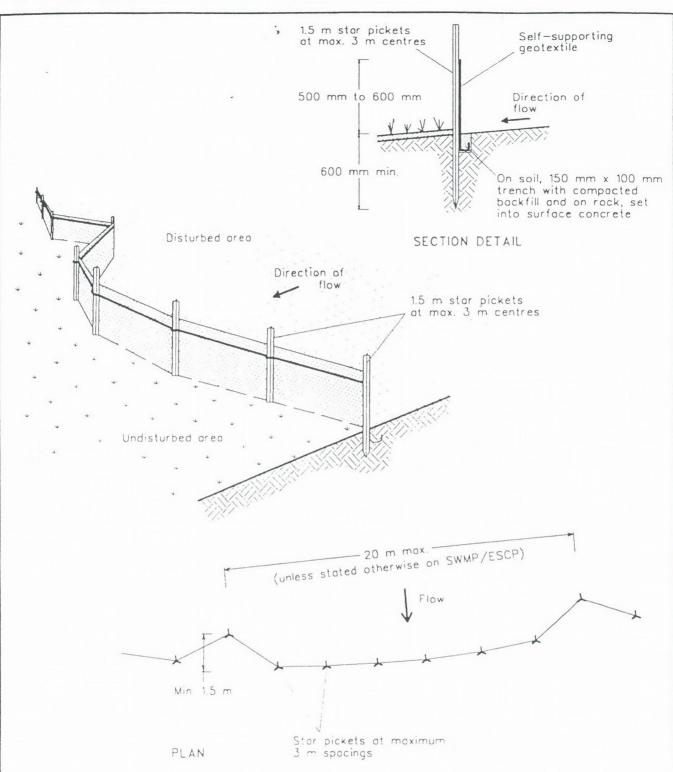
Environmental Impacts

- 1. Construct sediment fence as close as possible to parallel to the contours of the site
- 2. Drive 1.5 metre long star pickets into ground, 3 metres apart.
- 3. Dig a 150 mm deep trench along the upslope line of the fence for the bottom of the fabric to be entrenched
- 4. Backfill trench over base of fabric
- 5. Fix self-supporting geotextile to upslope side of posts with wire ties or as recommended by geotextile manufacturer.
- 6. Join sections of fabric at a support post with a 150 mm overlap.

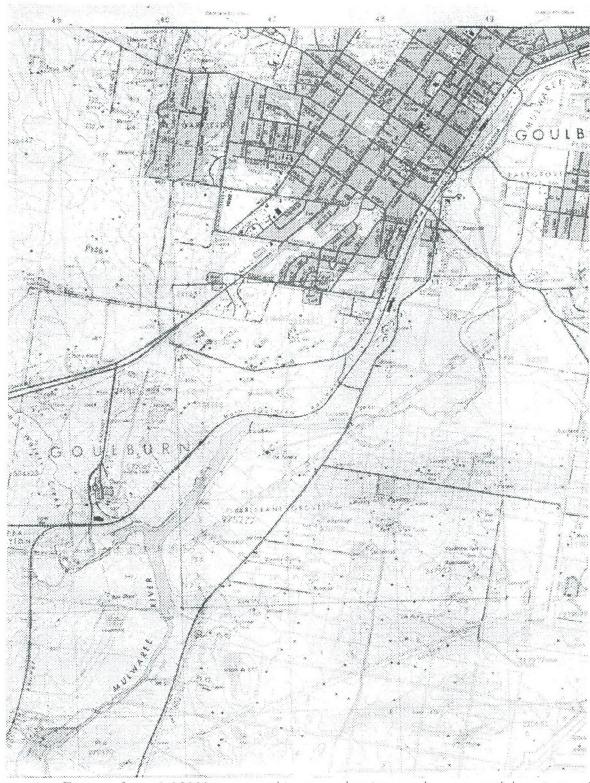
Figure 1: Excerpt from 1:25000 topographic map showing study area and locations of previously recorded archaeological sites. Thornes Bridge is highlighted in yellow; the heavier grid lines represent the 3km square area for which a survey of previously recorded sites was conducted. The locations of previously recorded sites are marked by a handwritten dot and a site number (eg as for G17 towards the top right margin of the defined search area).
