Slope Stabilisation on Henry Lawson Drive at Revesby Heights

Review of Environmental Factors

RTA ENVIRONMENTAL TECHNOLOGY

FEBRUARY 2006

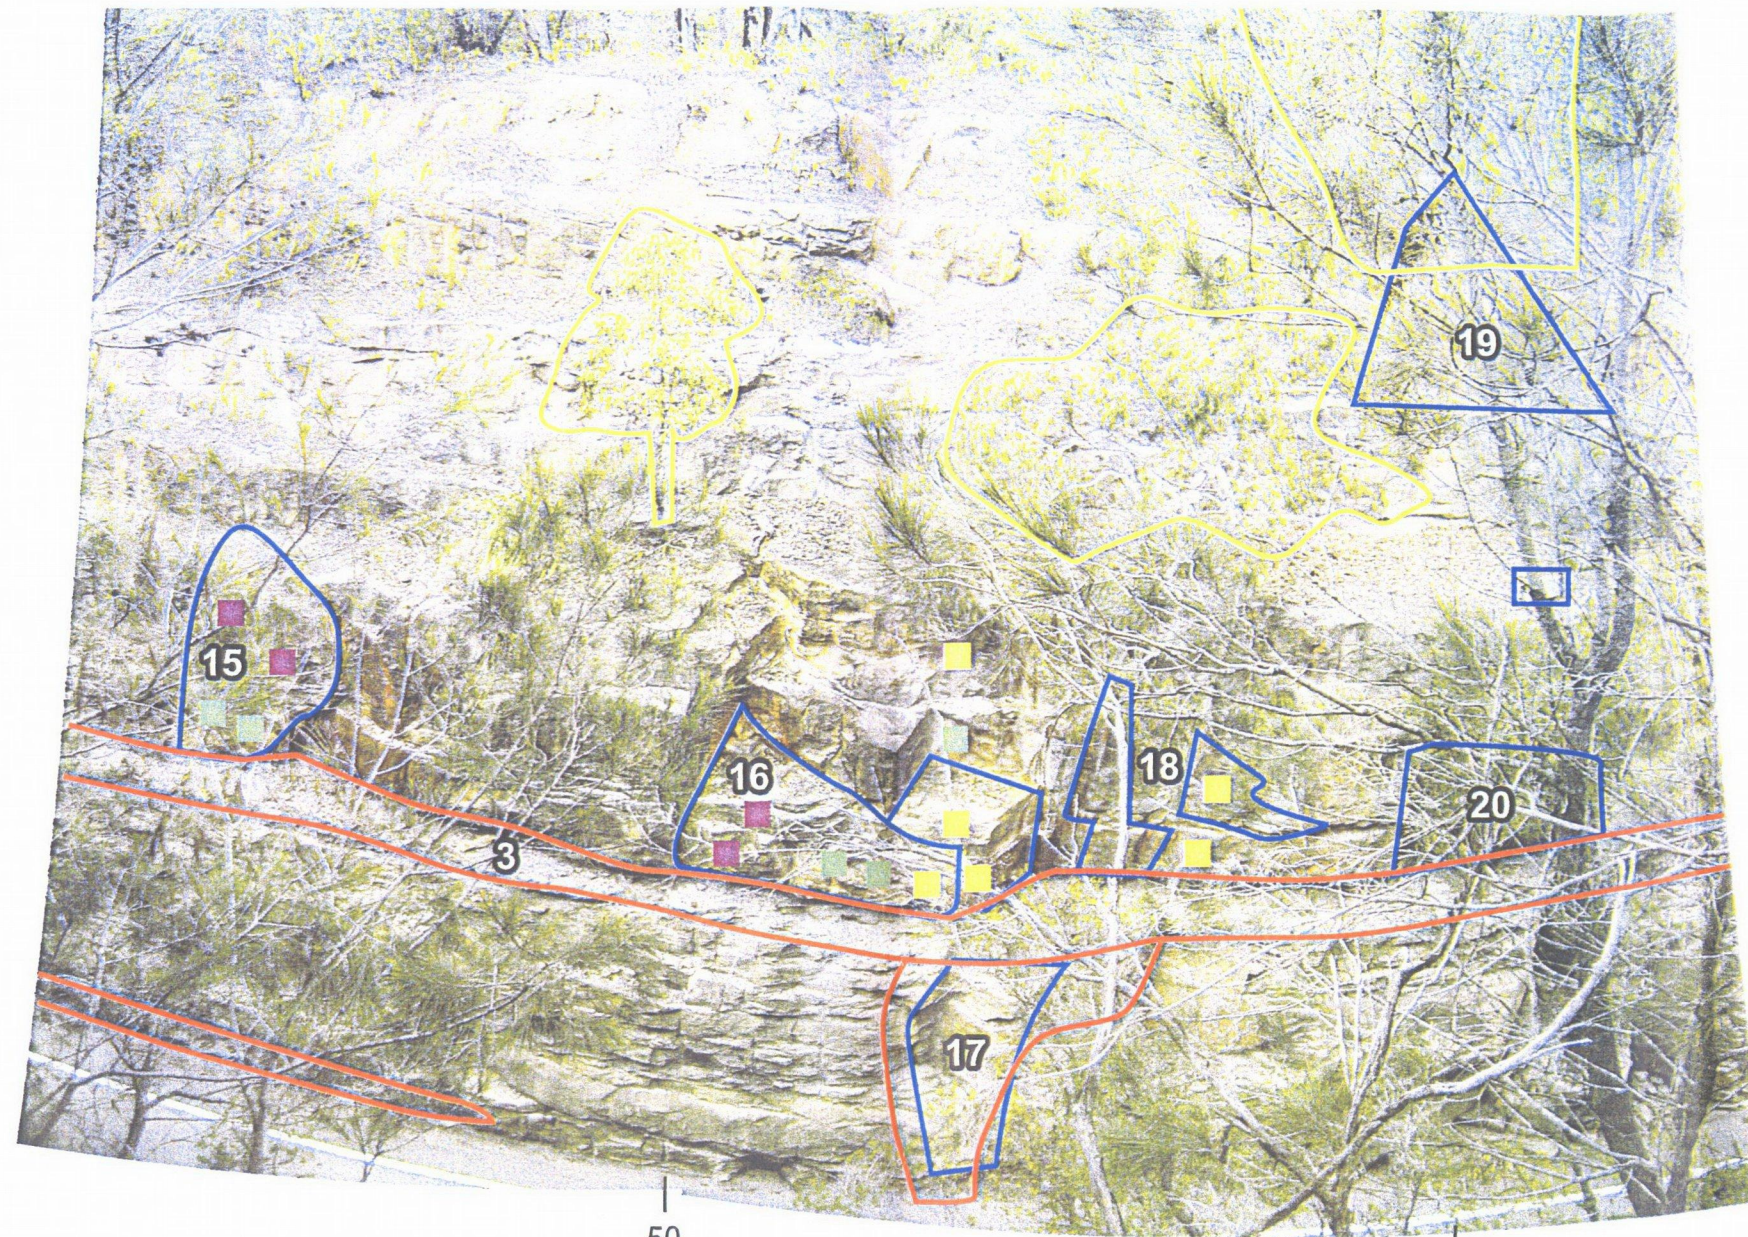
Job No: 21/14200
Revision No: 0
Photomosaic Date: 28 September 2005
Mark-up Date: October 2005
Plate No: 3 of 6

ROCKBOLTS

- 1.5m LENGTH
- 2.0m LENGTH
- 3.0m LENGTH
- 4.0m LENGTH

ROADS & TRAFFIC AUTHORITY
HENRY LAWSON DRIVE, REVESBY HEIGHTS
ROCK CUTTING ID No. 1969
STABILISATION TREATMENT REQUIREMENTS

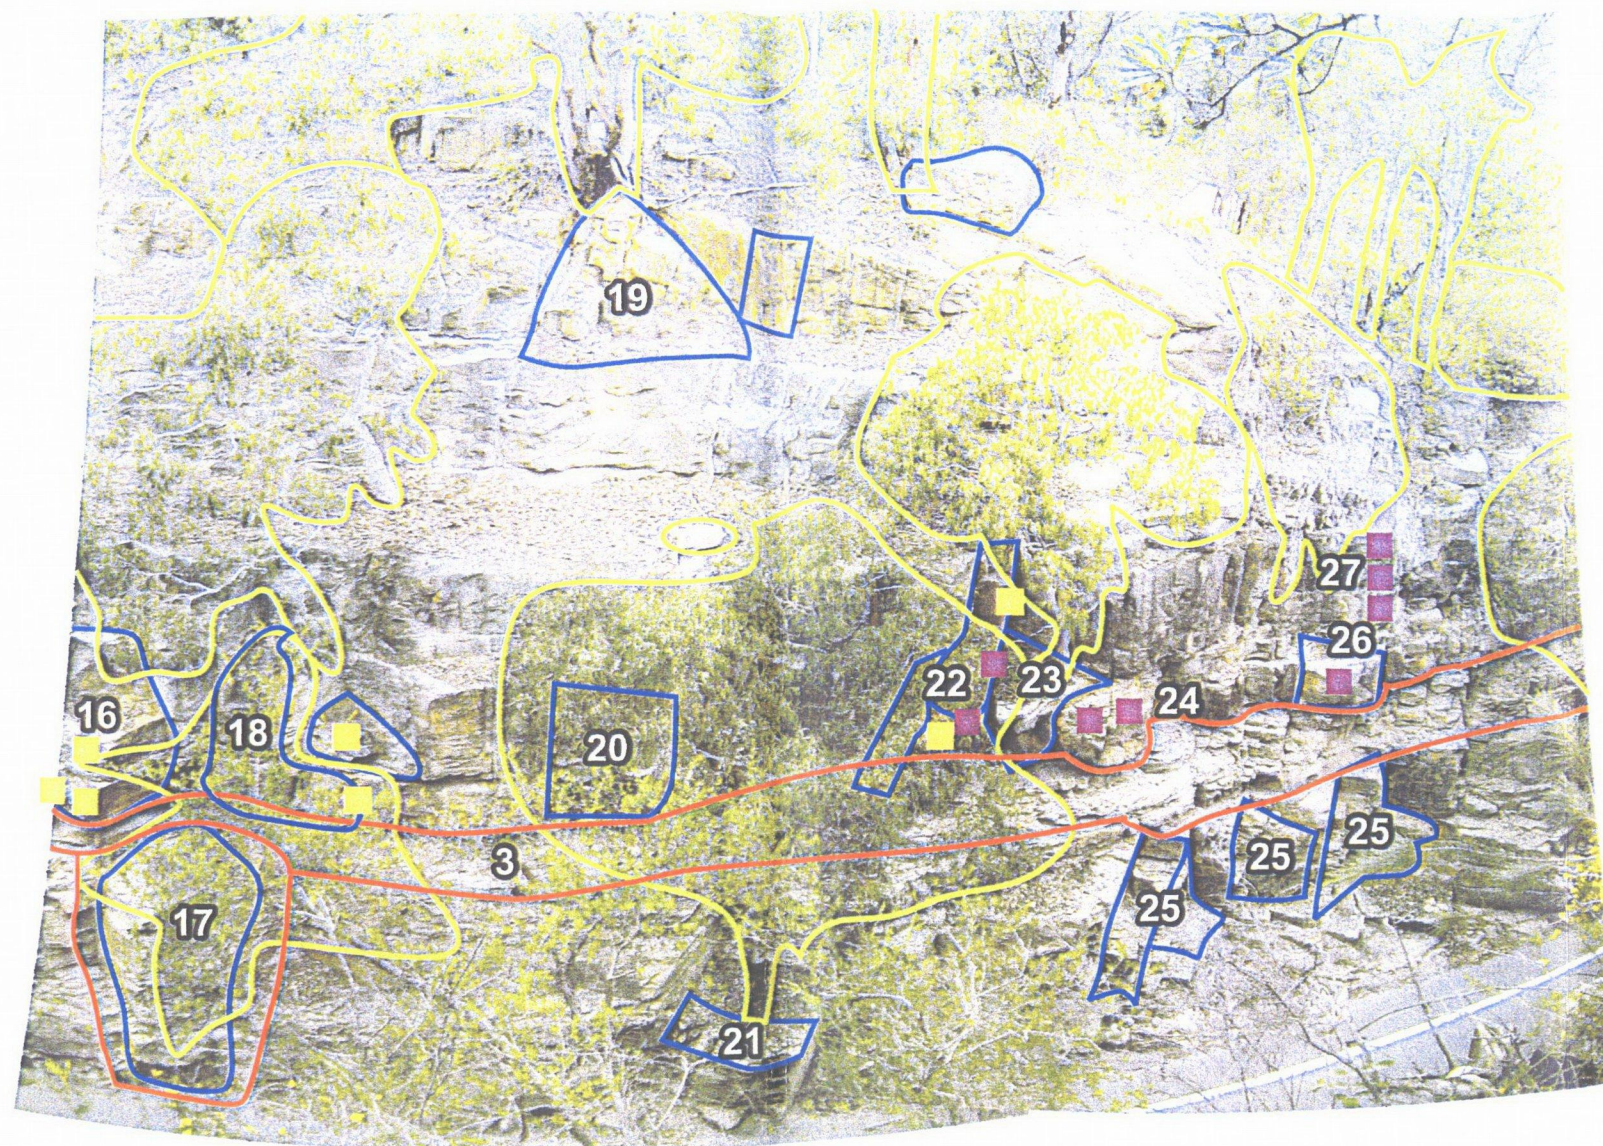
Job No: 21/14200
Revision No: 0
Photomosaic Date: 28 September 2005
Mark-up Date: October 2005
Plate No: 4 of 6

ROCKBOLTS

- 1.5m LENGTH
- 2.0m LENGTH
- 3.0m LENGTH
- 4.0m LENGTH

ROADS & TRAFFIC AUTHORITY
HENRY LAWSON DRIVE, REVESBY HEIGHTS
ROCK CUTTING ID No. 1969
STABILISATION TREATMENT REQUIREMENTS
